# ASSESSING THE STATE OF TOMAHAWK LAKE'S SHORELANDS - 2020

Mike Meyer and Jim Kreitlow  
Nova Ecological Services  
Manitowish Waters, WI  
August 1, 2020

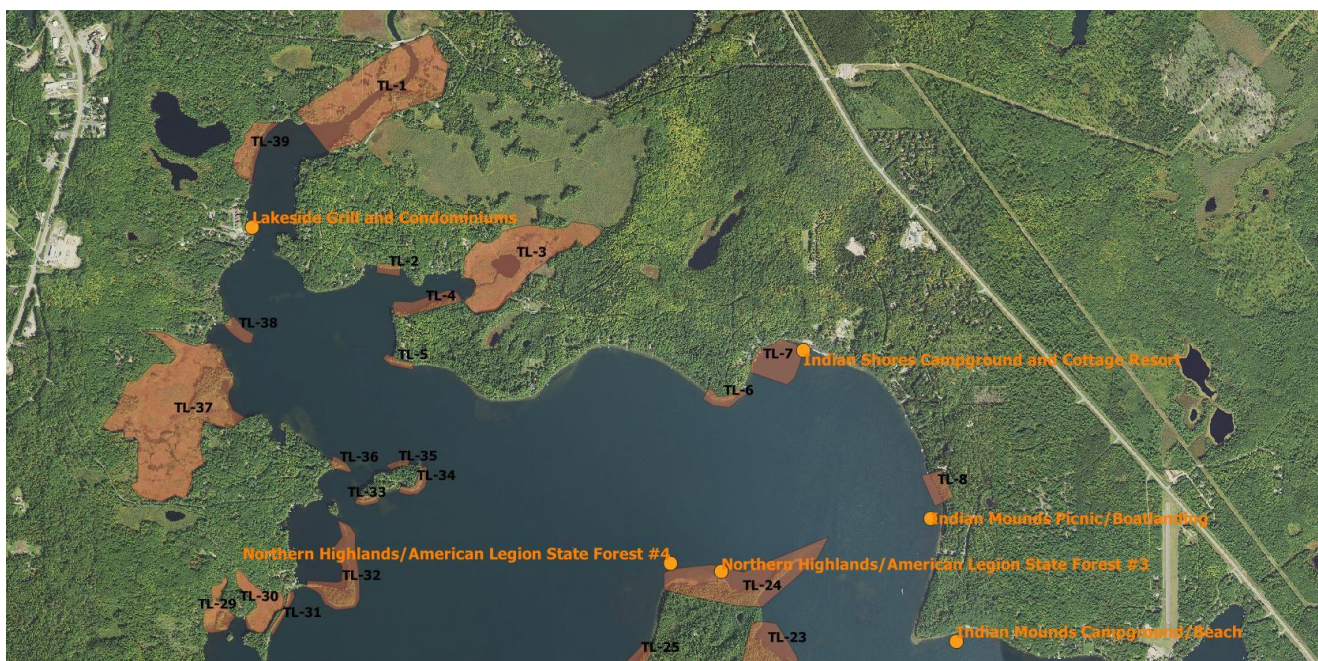
Figure 1. Concentrated Use Sites on Tomahawk Lake - North

A survey was conducted on Friday July 5 to identify properties on Tomahawk Lake with high concentrations of human activity including beach use, boating, commercial operations, recreation, and presence of 15+ people at properties during the surveys. The locations of these public and private properties are shown in comparison to Critical Habitat sites in the maps below. Operators of these properties should be made aware of important natural features in proximity to their operations and the shoreland best management practices that could be undertaken to minimize sediment and nutrient run-off and maximize the protection and restoration of natural habitat on their properties.

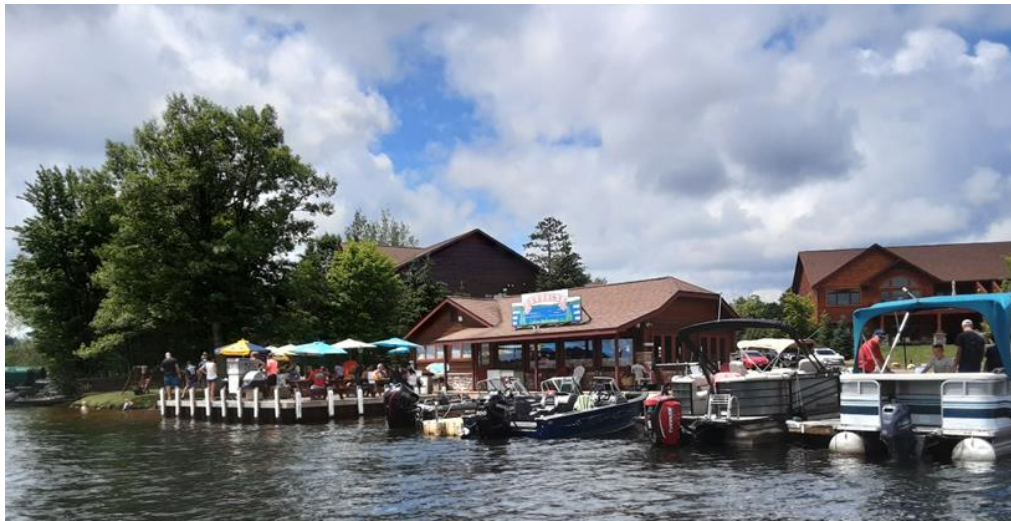
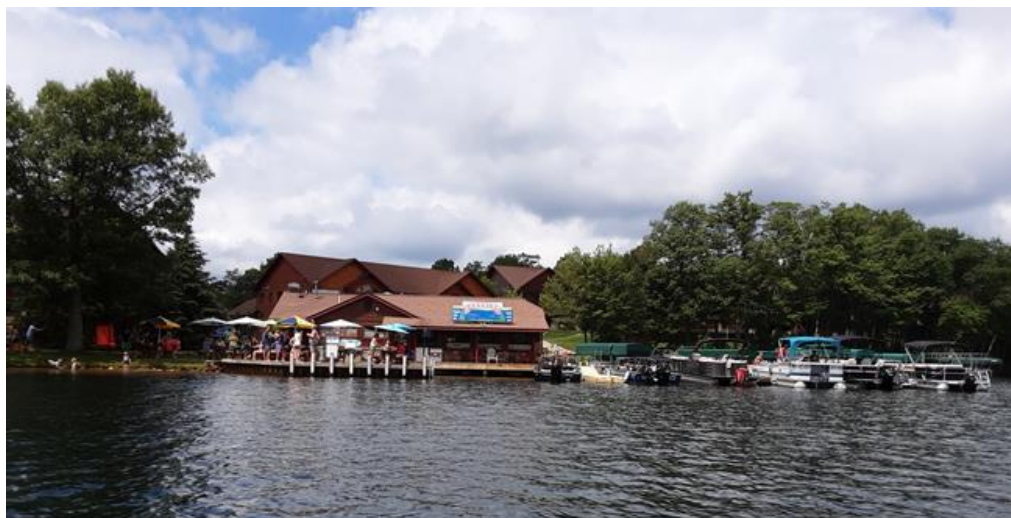
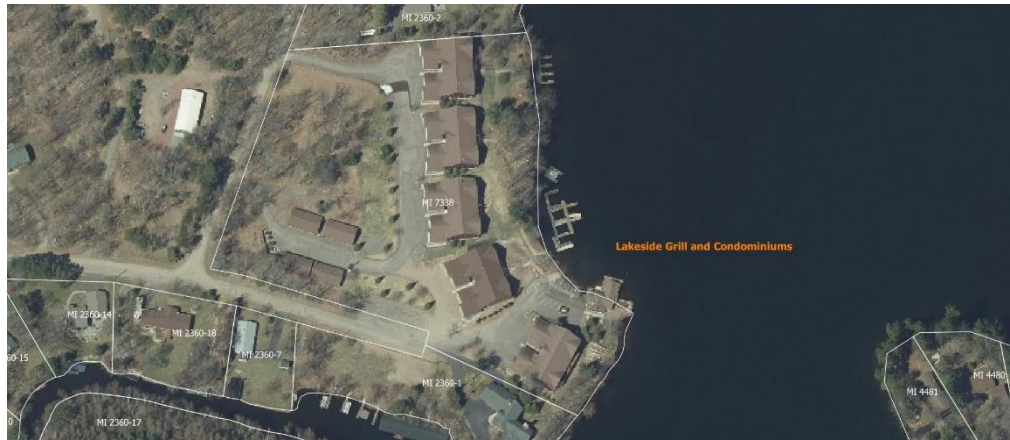
**Figure 3. Lakeside Grill Photos and Aerial Map**

This popular shoreline restaurant and bar serves customers that arrive by boat and auto. The outside deck is a big draw during warm summer afternoons and evenings. Several condominium units are also on the property. At the time of our survey on July 5<sup>th</sup> there were 7 boats moored and 65 people at the tables and along the shoreline. Much of the property is covered with pavement and roof tops (impervious surfaces) so practices that minimize run-off to the lake should be employed. Over 50% of the shoreland buffer is impervious surface or manicured lawn but some natural shoreland vegetation remains on the north end of the property and should be maintained. There is little natural habitat on the property shoreline near the restaurant— given its concentrated use it may be difficult to restore or conserve, but an attempt should be encouraged. There were 17 piers and 13 boat lifts present.

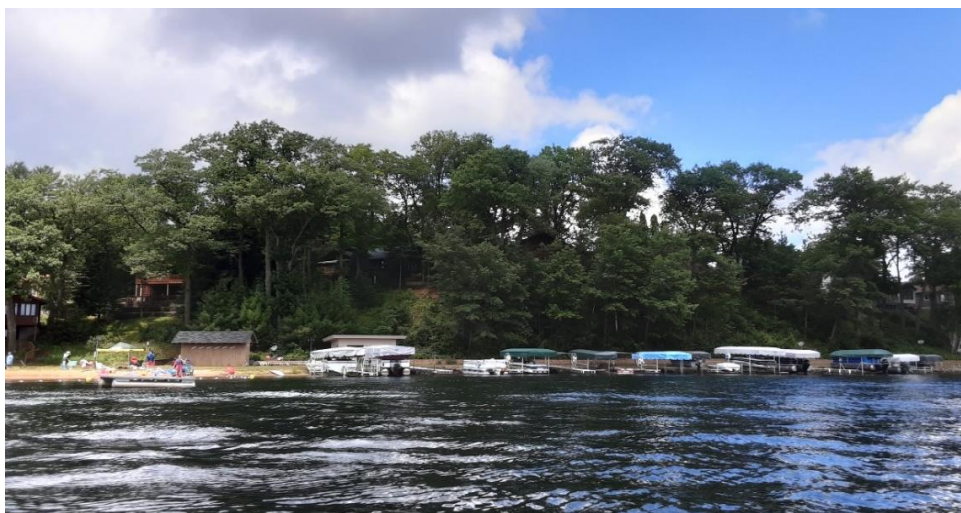
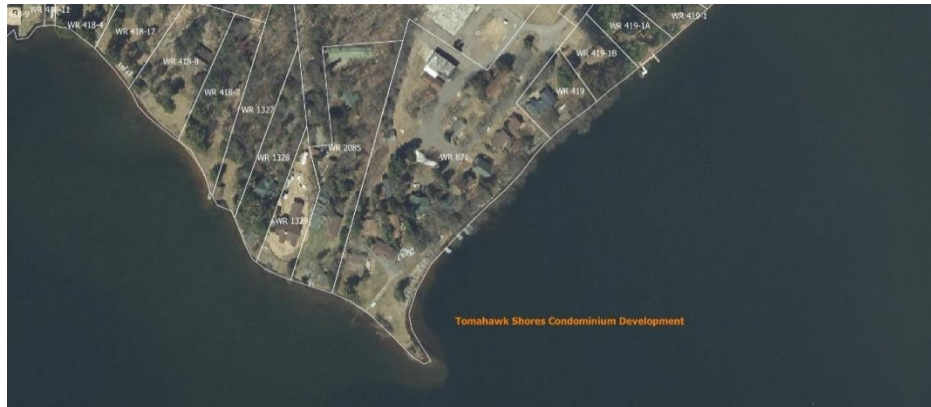
**Figure 5. Tomahawk Shores Photos**

There is no publicly available information on the *Tomahawk Shores Owners Association* LTD or other information related to the condominium development via the internet. During our shoreline inventory survey of the property on July 19 the buffer was estimated at 35% lawn and impervious surface and there was about 40' of artificial beach. Thirteen piers were counted along with 15 boat lifts. Approximately 25 people were present at the beach and along the shoreline during our July 5 Concentrated Use survey. There was no evident erosion, channeling or gullying from run-off, or bare soil but because of the concentrated use of the site and steep slopes on the north end of the property, care should be taken to divert any potential run-off from reaching the lake or creating erosion.

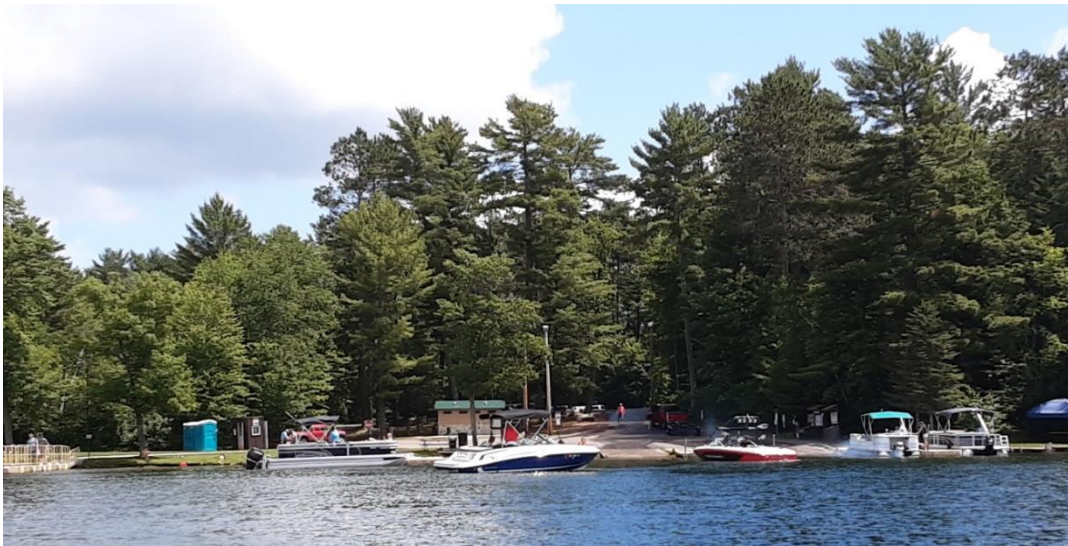
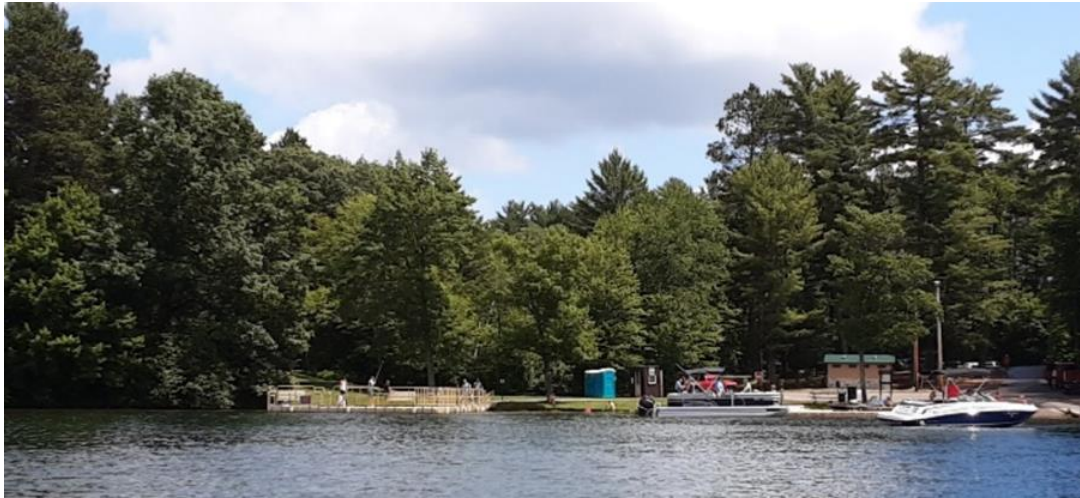
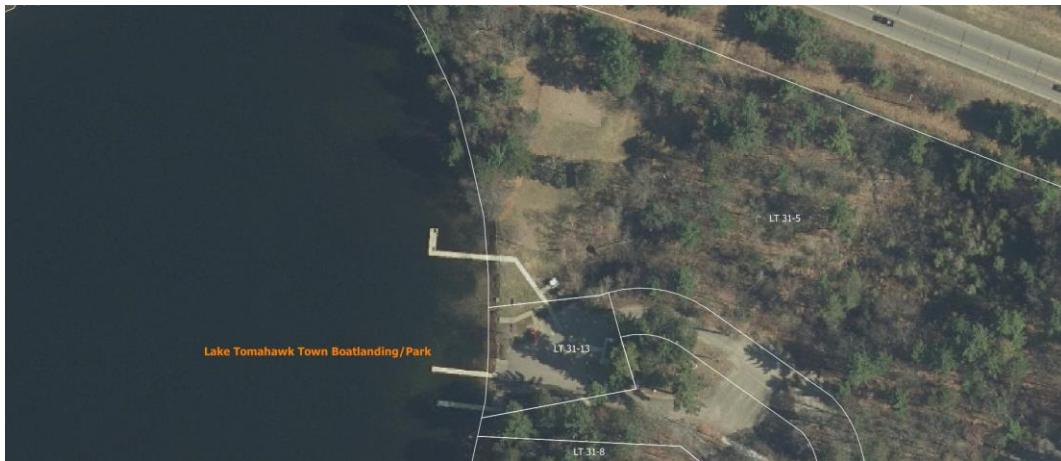
**Figure 6. Lake Tomahawk Town Boat Landing Park Photos**

The Lake Tomahawk Boat Landing Park is a primary access point for boaters (ice-free seasons) and ice fisherman and snowmobiles (winter). The shoreland buffer adjacent to the park is in natural vegetation while that near the boat landing is primarily impervious surface and lawn. Despite the large amount of impervious surface present there was little sign of channeling or gullies and little bare soil. The potential for run-off does exist so an effort to divert run-off from the access road which has a steep grade would be beneficial.

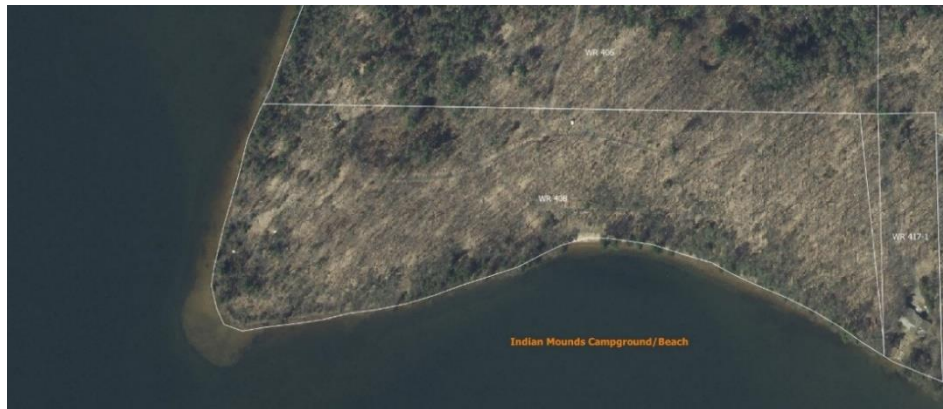
Figure 9. Indian Mounds Campground/Beach Photos

There are 39 campsites at this WDNR property and a beach area. The campground is open for camping when snow-free and generally at capacity during July and August. There are steep slopes along a portion of the northern shore with extensive erosion, gullying/channeling, and surface water run-off due to foot traffic associated with the campsites. Boats are moored along the shoreline as well, without improved docking sites.

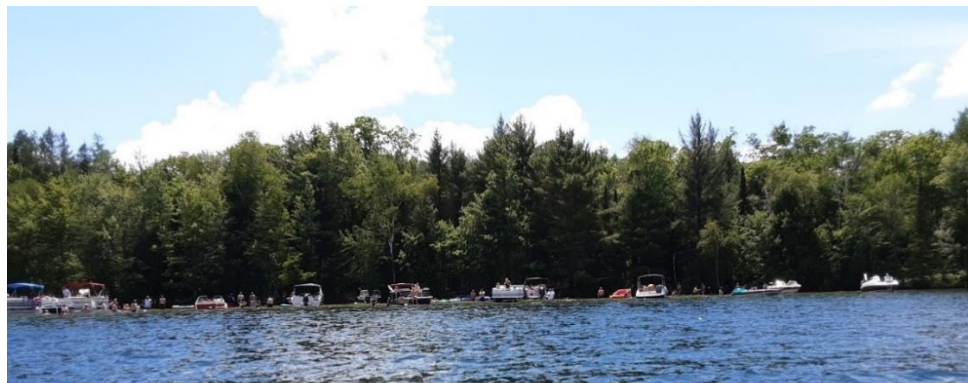
**Figure 10. Northern Highland/American Legion State Forest #1 Photos**

There are 4 locations on State of Wisconsin shoreland parcels where we noted large numbers of boats and jet skis anchored or pulled ashore along long stretches of shoreline. These areas are relatively shallow and sandy, offering ideal swimming and water sport (water skiing, waterboarding, jet skiing) staging areas. When we conducted the survey between 1PM and 2PM on July 5 there were 15 boats moored and 62 people enjoying site #1. Despite this high level of use, only 40' of bank erosion was noted – the upland area is level. This area is adjacent to and within Critical Habitat site TL-17 (See companion report on Critical Habitat).

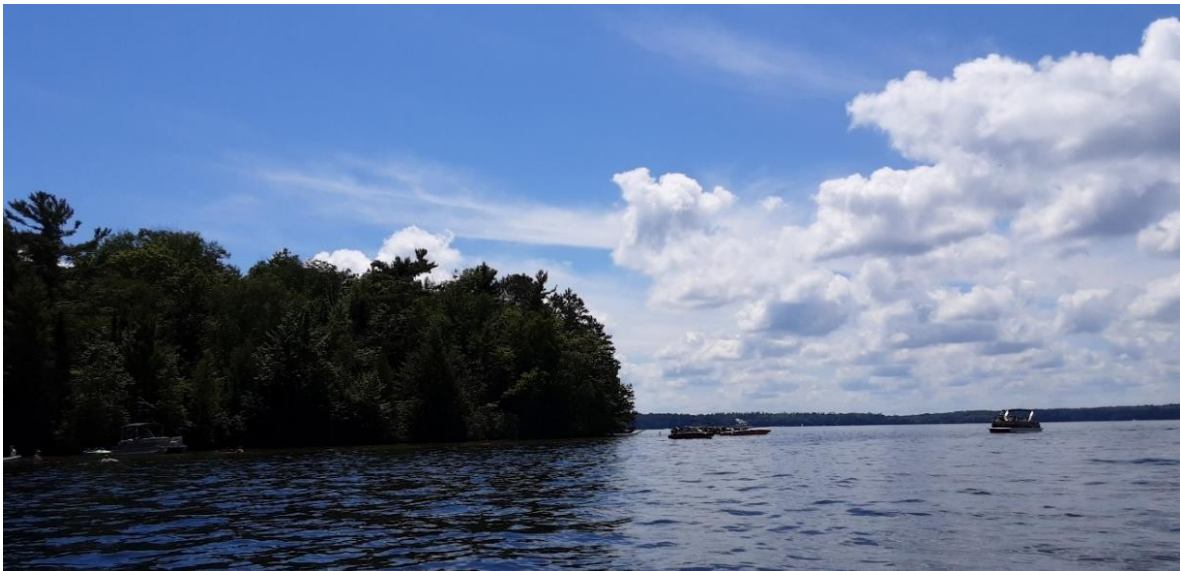
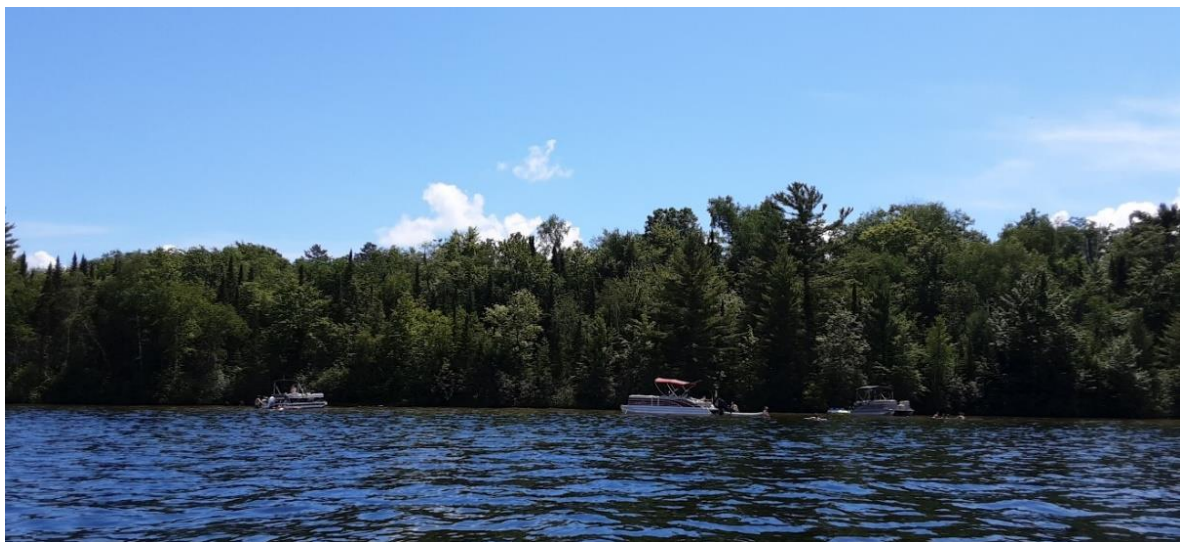
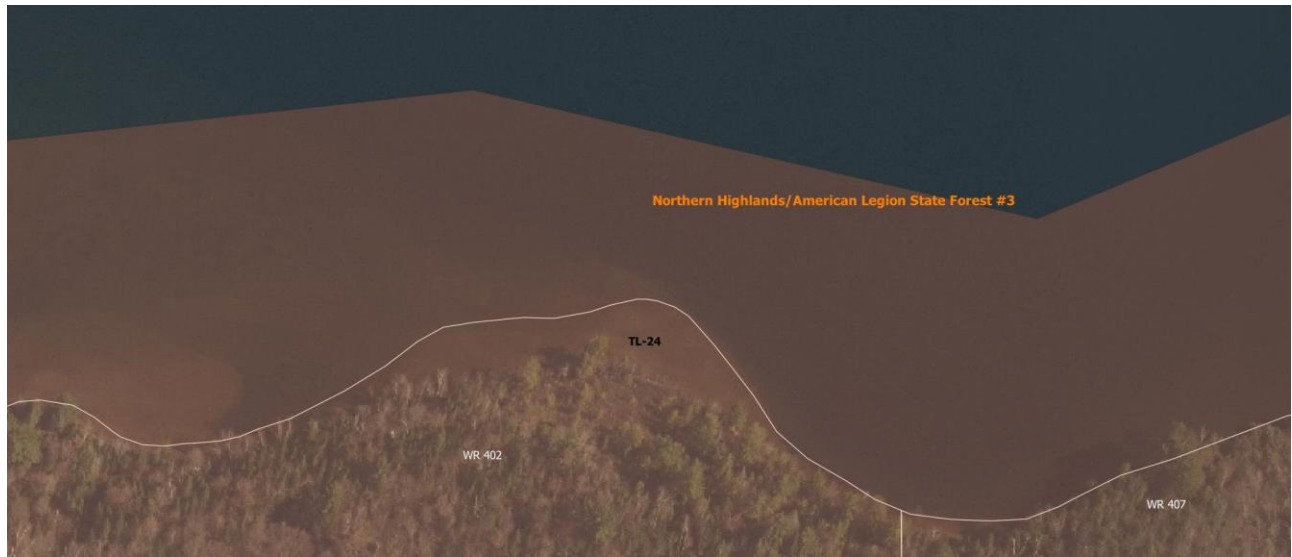
**Figure 12. Northern Highlands/American Legion State Forest #3 Photos**

Two concentrated use areas were located on the north shoreline of Windy Point. At the time of the July 5<sup>th</sup> survey there were 25 boats and 3 jet skis at anchor and between 80-100 people present on the shoreline, in anchored boats, or in the water. Several ski boats and jet skis were actively using the area. Extensive gullying and channeling of the adjacent uplands and buffer was associated with the activity as well as bank erosion. These sites have the most severe erosion problems on Tomahawk Lake and are within Critical Habitat site TL-24 (See companion report on Critical Habitat for more information).
